WELL CONTROL ALERT

Alert #16-2

Well Control Incident

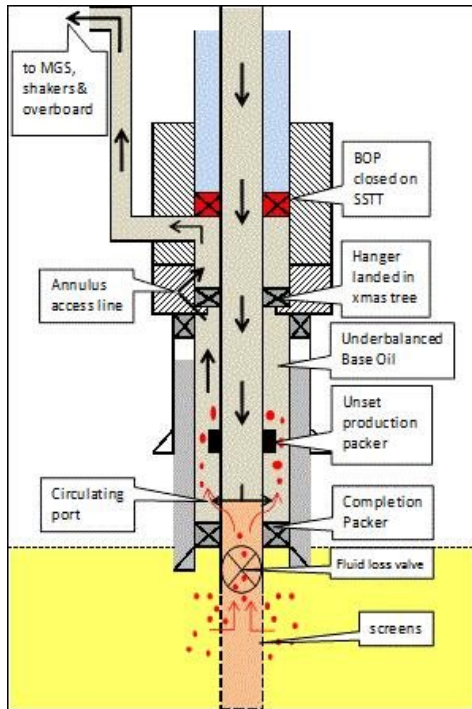
Figure 1

- Fluid Loss Valve failed unexpectedly to the open position. The cause of the valve opening could not be determined (i.e. failed open or opened unintentionally).
